Technical Guide

Guide to Assessment and Repair of Flood Damaged Timber and Timber Framed Houses

(Revised Feb 2015)

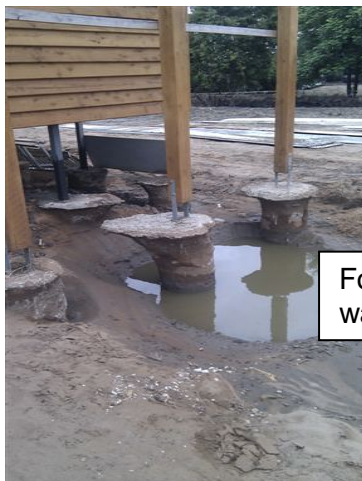
Footings scoured out by fast flowing water

Failure to address or correct these types of faults could severely affect the future structural performance of the building.

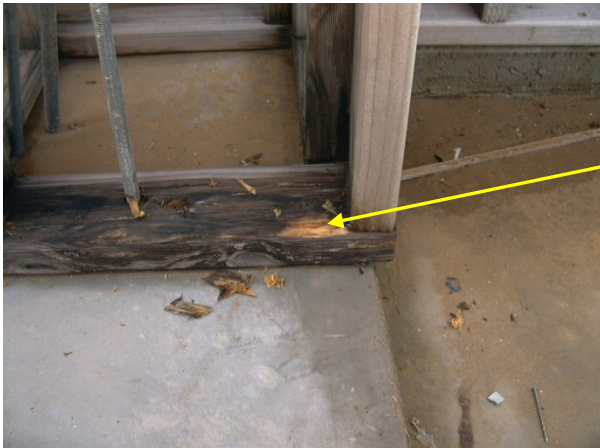
Although heavily discoloured with surface mould and blue stain, the pine timber is still sound as shown by scraping back the surface layer

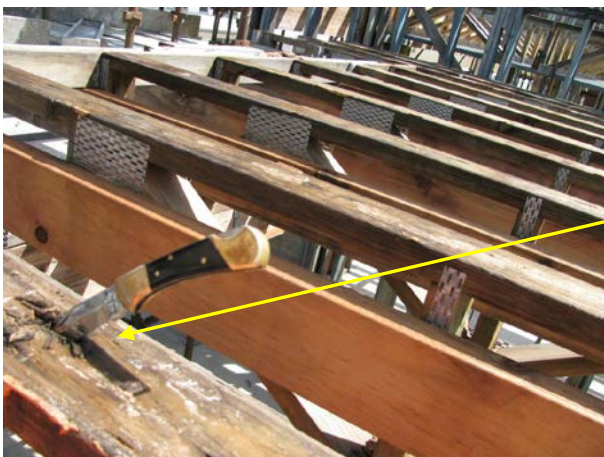
Decayed timber is soft and spongy and can easily be penetrated with a knife or screwdriver

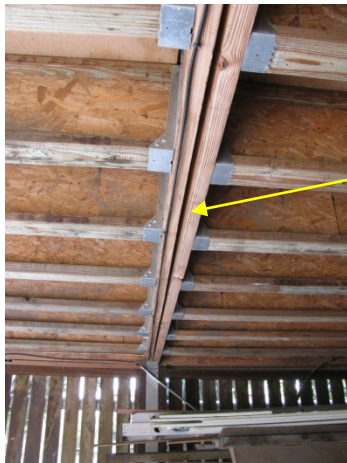
Expansion of the hardwood T&G floor above has caused the separation of double bearers.

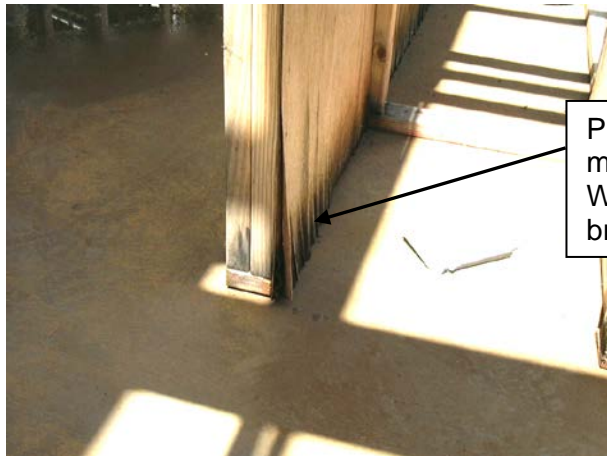
Plywood sheet bracing affected by moisture. Replacement required. Where necessary fix temporary braces.

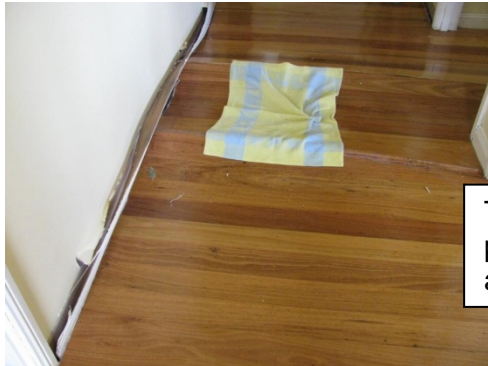
This inundated T&G floor over particleboard tented about 1 week after the water receded.

Allow the flooring a minimum of 4 months to dry out before re-assessing. Gaps between boards are highly likely to occur as the floor dries out, however the structural adequacy of the flooring is not likely to have been compromised and floors may be lived on in the meantime.
