LOOK OUT FOR European House Borer

Prepared by: The Forest Health Consultative Committee on European House Borer.

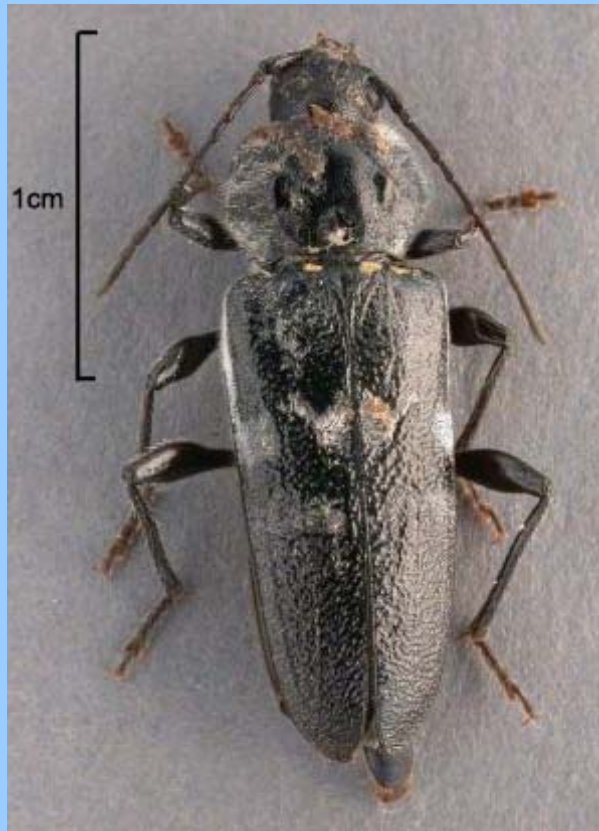
Above: Adult European house borer – Picture not to scale
(Dept of Agriculture Western Australia)

- Adult beetles which are brownish-black to black and have a slightly flattened appearance. Beetle wing are usually all black and may have distinctive white patches. The top surface of the first body segment behind the head has two raised, black, shiny knobs, two of these are like eyes. Adults are about 18-25mm in length with antennae that are about half as long as the body.

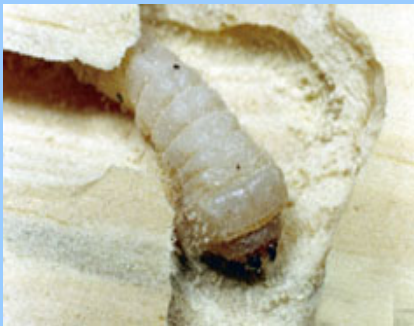
Above: Exposed larvae boring through timber. Picture not to scale (Clemson University USDA Cooperative Extension Slide Series)

- Galleries within the timber are formed by the boring larvae and are frequently tightly packed with frass. Galleries within the timber rarely break through the surface of the timber and therefore are seldom detected. However, long blister-like swellings under the surface of the thin layer of uneaten wood caused by the tightly-packed frass may be evident.

- A soft scraping sound made by the larvae as they feed which can often be heard at night and may be audible from some distance.
- EHB larvae within the timber. Larvae are elongate and cylindrical in shape with an enlarged and flattened head. The length of larvae varies between 19-41mm and around 7.5mm wide at maturity. Larvae can be identified by a row of three small black single-lens eyes on each side of the head.
- Batches of up to 120 eggs which are laid in crevices or cracks in timber.
