# **Treating timber: processes, solutions & new developments**

## **Setting the bar: fixing and maintaining standards for treated timber**

# Hyne and Son - Tuan

## Preservative Treated Timber Manufacturers

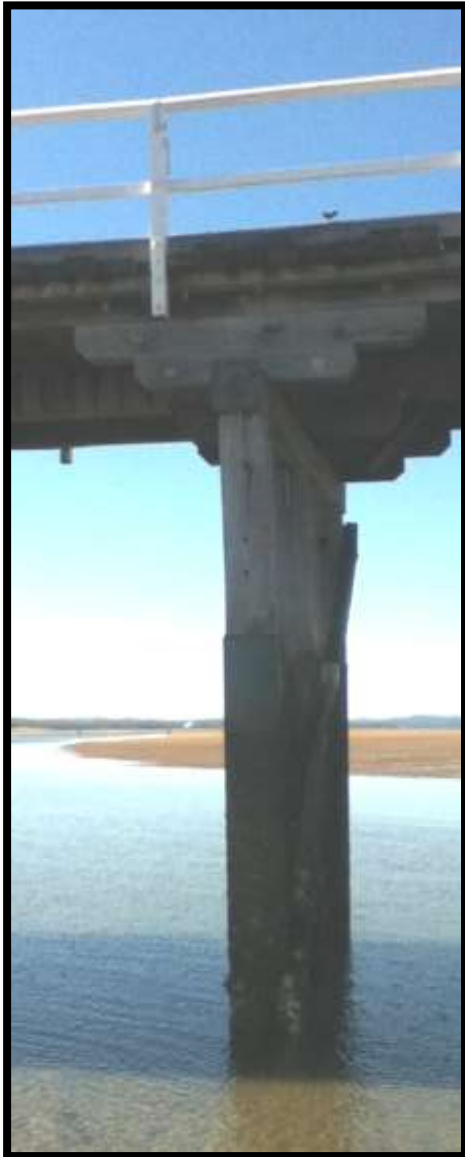
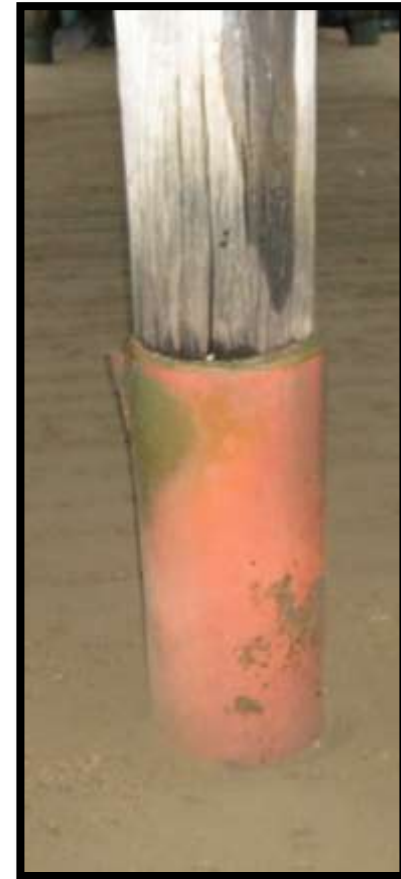
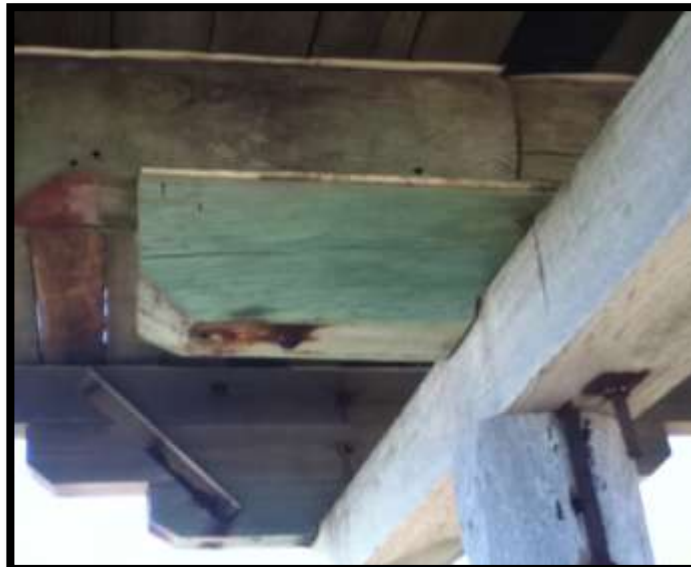
# Urangan Pier Details

- Well designed
- Good timber
- Well built
- Well maintained
- 100+ service life

- Built 1913 → 1917
- Originally 1120 m long
- Sugar, timber and coal export
- Closed 1985
- 250 m demolished
- Restored & reopened 1999

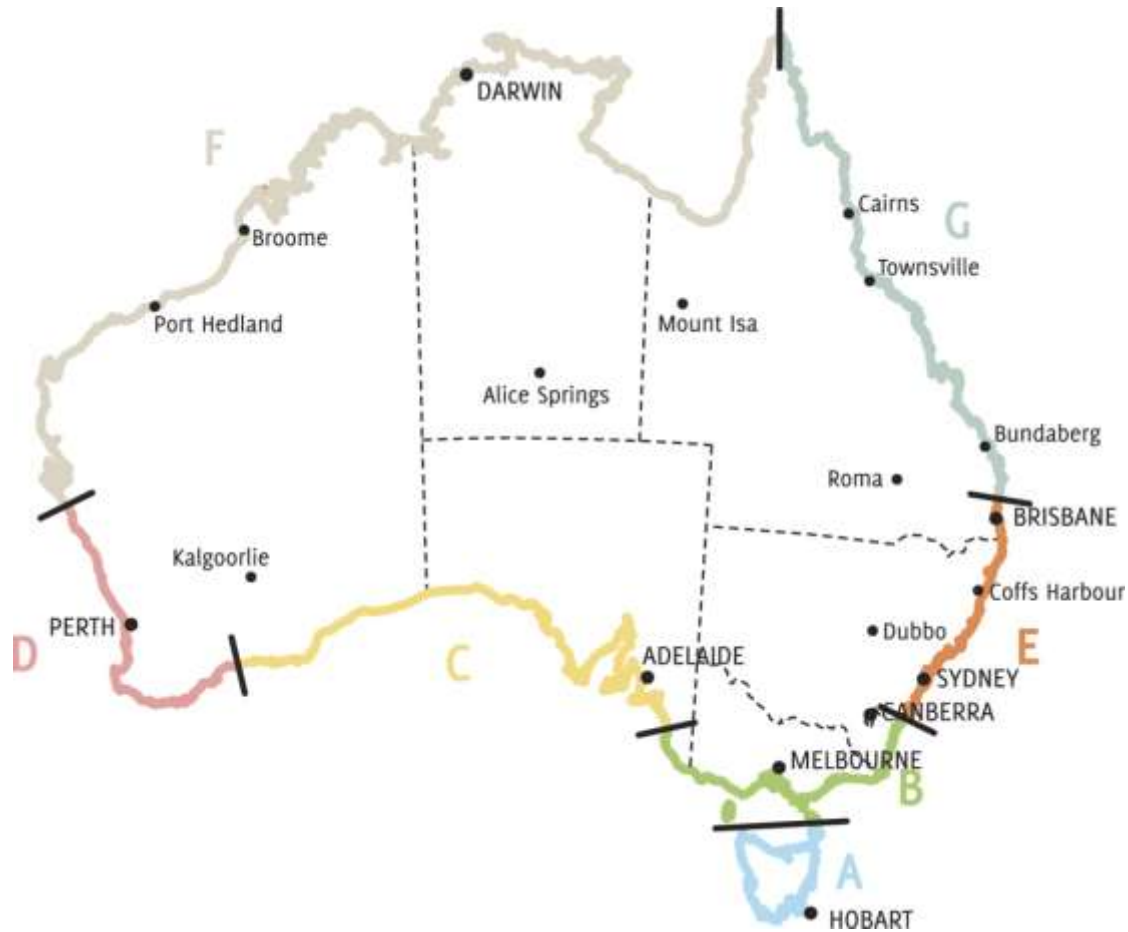
Figure 6.3.1. Marine borer hazard zones. Zone G is the most hazardous.

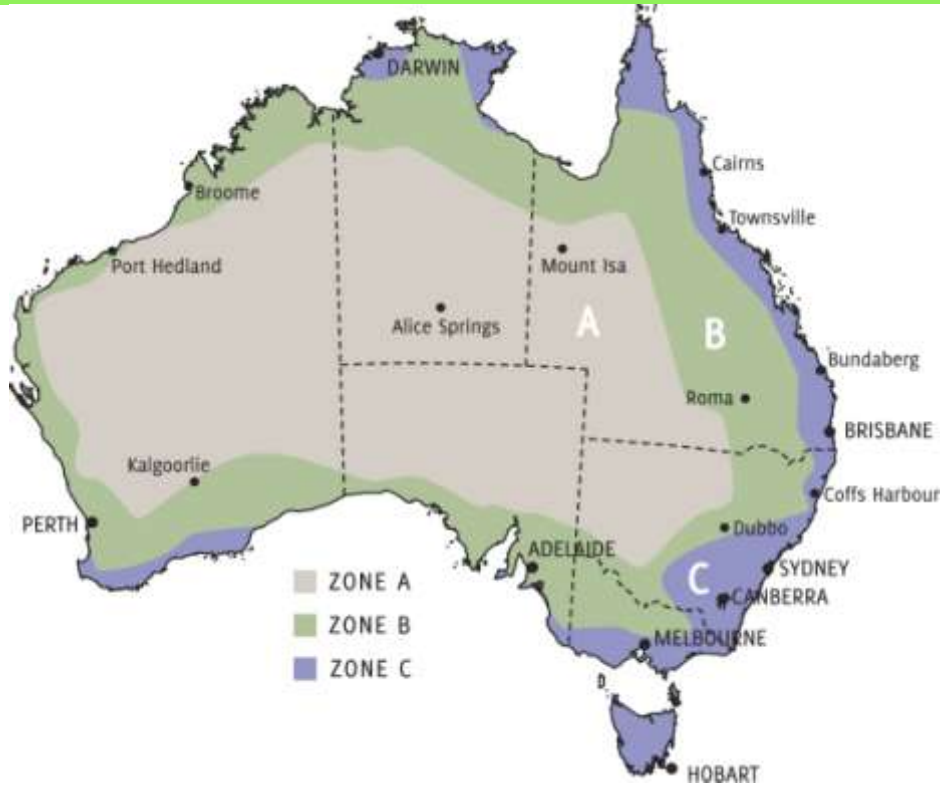
**Figure 7.2.1.1** Embedded corrosion hazard zone map. Zone C is most hazardous

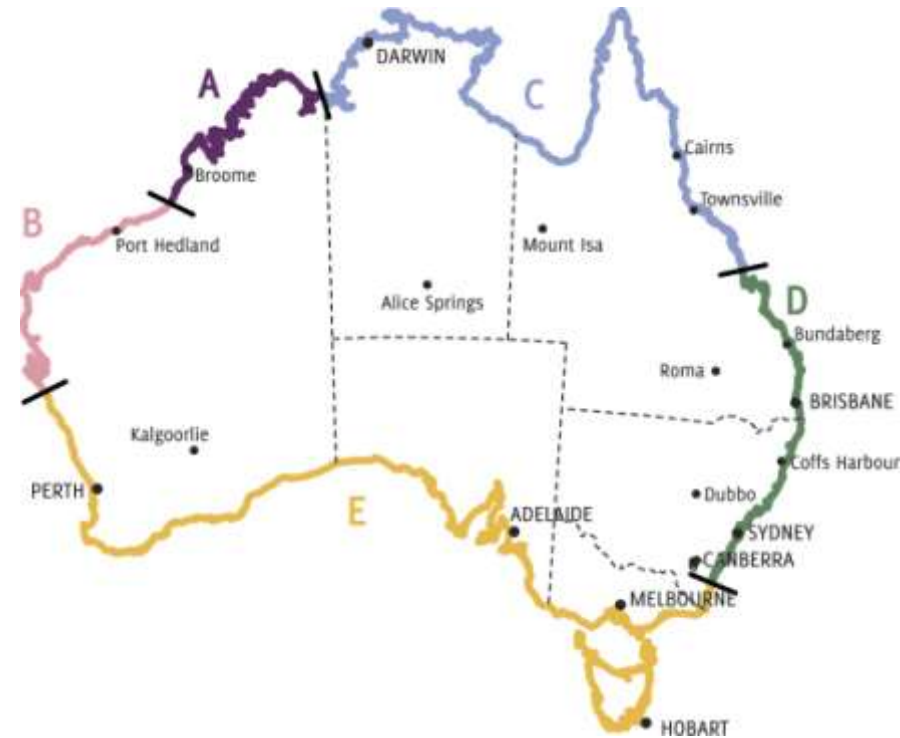
**Figure 7.3.1.1** Coastal Hazard Zones. Zone E has the greatest hazard.

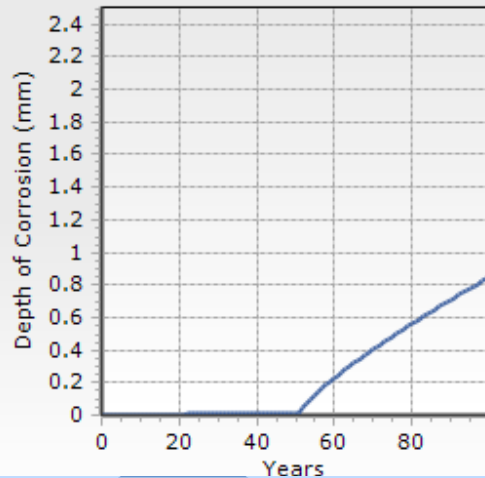
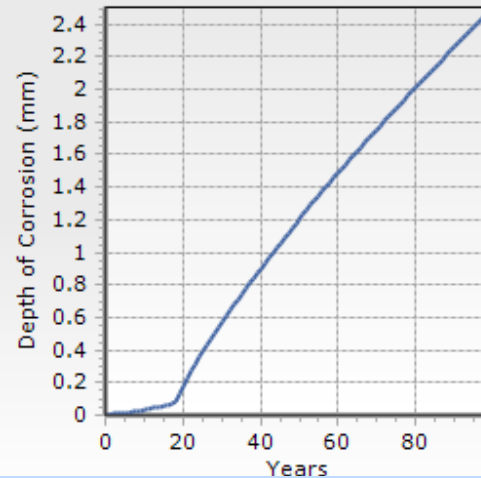
# Design Example : Bolted Timber Joint

### Atmospheric Corrosion

### Embedded Corrosion

Description	Exposed To Weather
Hazard Zone (Atmospheric Corrosion)	D
Hazard Zone (Embedded Corrosion)	C
Connector Type	Bolt
Zinc Thickness (µm)	10
Steel Thickness (mm)	M12
Timber Treatment	Untreated or Non-CCA Treated Timber
Timber Species	Ironbark, red (broad-leaved)
Coastal Exposure	Partially Closed Bay
Site Classification	Open to Sea
Outdoor Microclimate	Sheltered or Partly Sheltered from Rain
Distance To Coast (km)	0.1
Industry Presence	Yes (within 20 km)
Industry Type	Light Industry (e.g. assembly plants)
Distance To Industry (km)	2

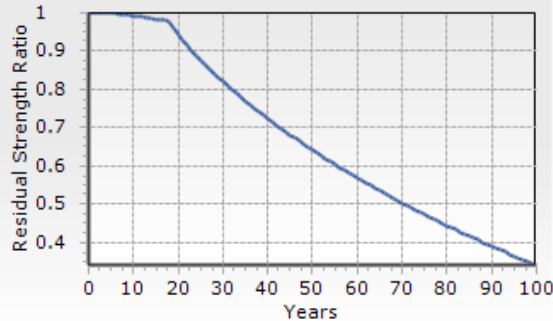
### Withdrawal Loading

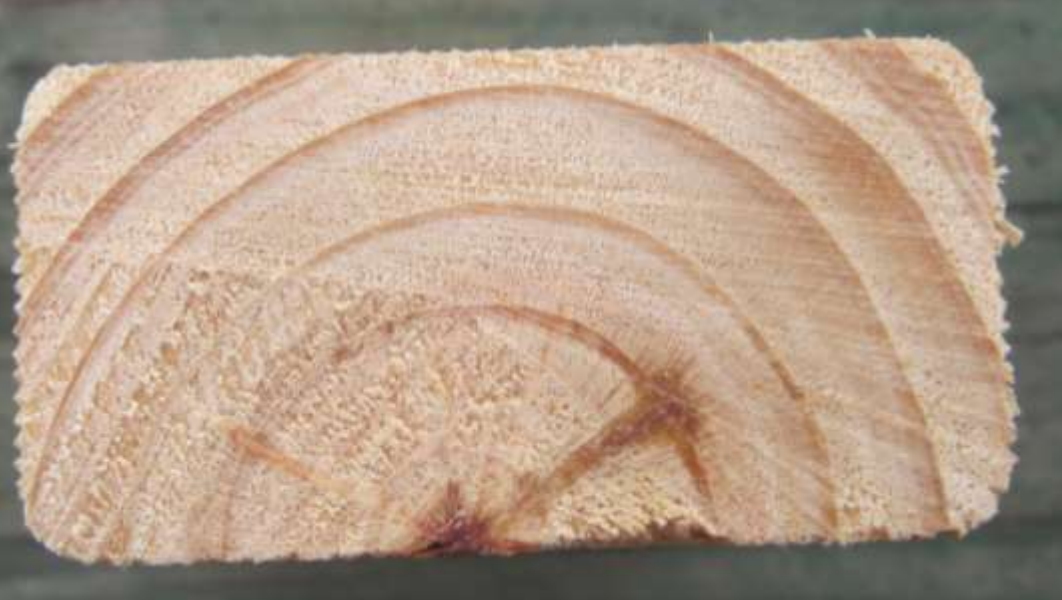
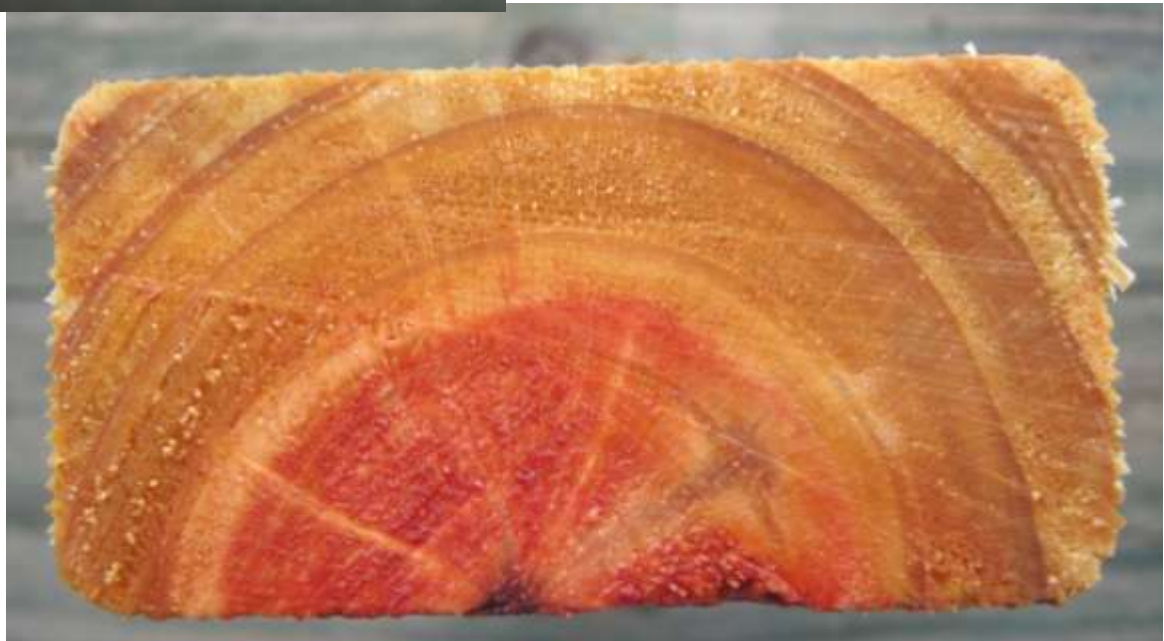
# Sapwood / Heartwood Indicator Test

+ Variamine Blue  
RT Salt solution  
+ 4% ammonia  
solution

Heartwood and  
Sapwood are  
differentiated.

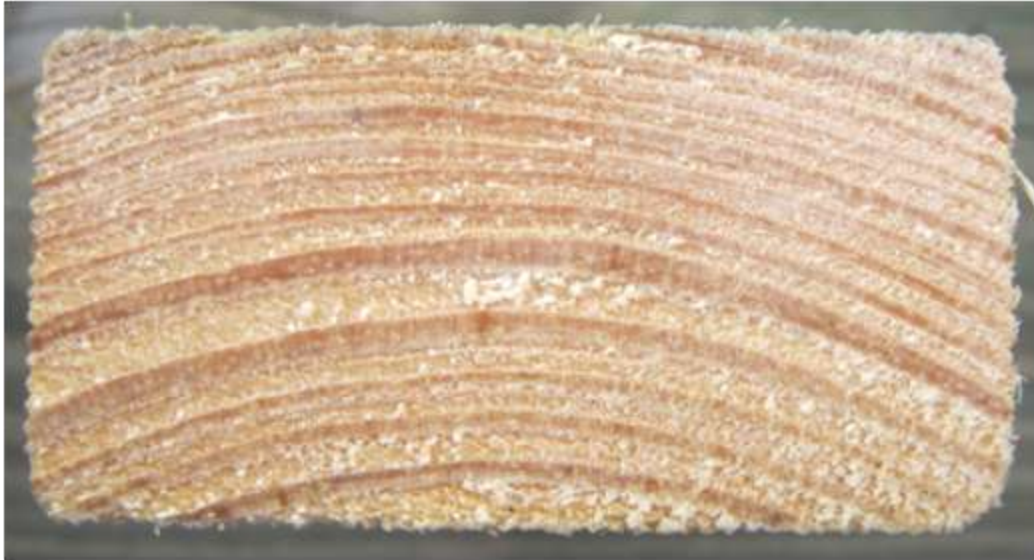
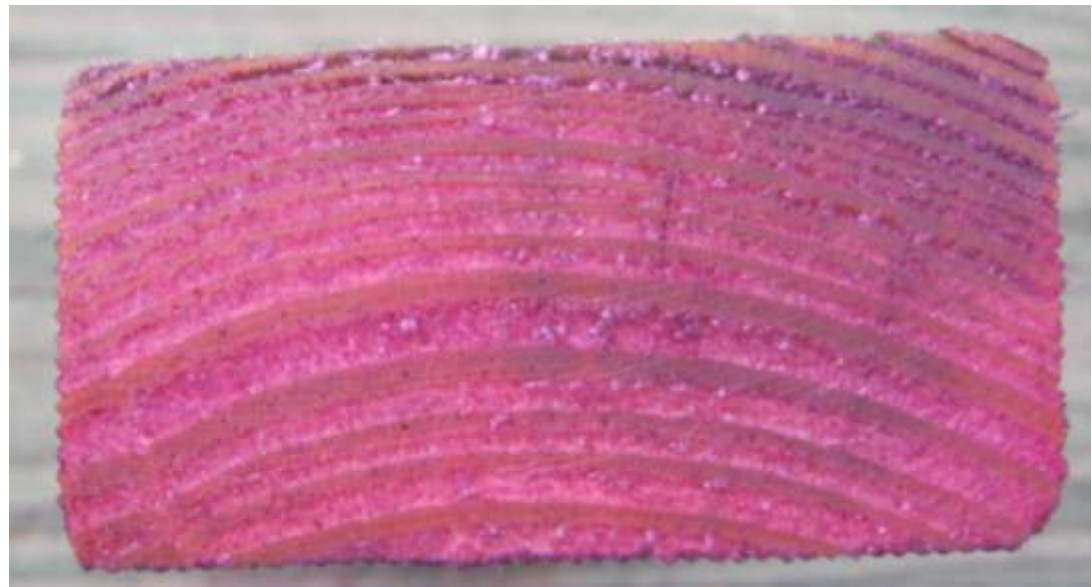
# Preservative Indicator Test

+ Pan Indicator

Preservative penetration is determined

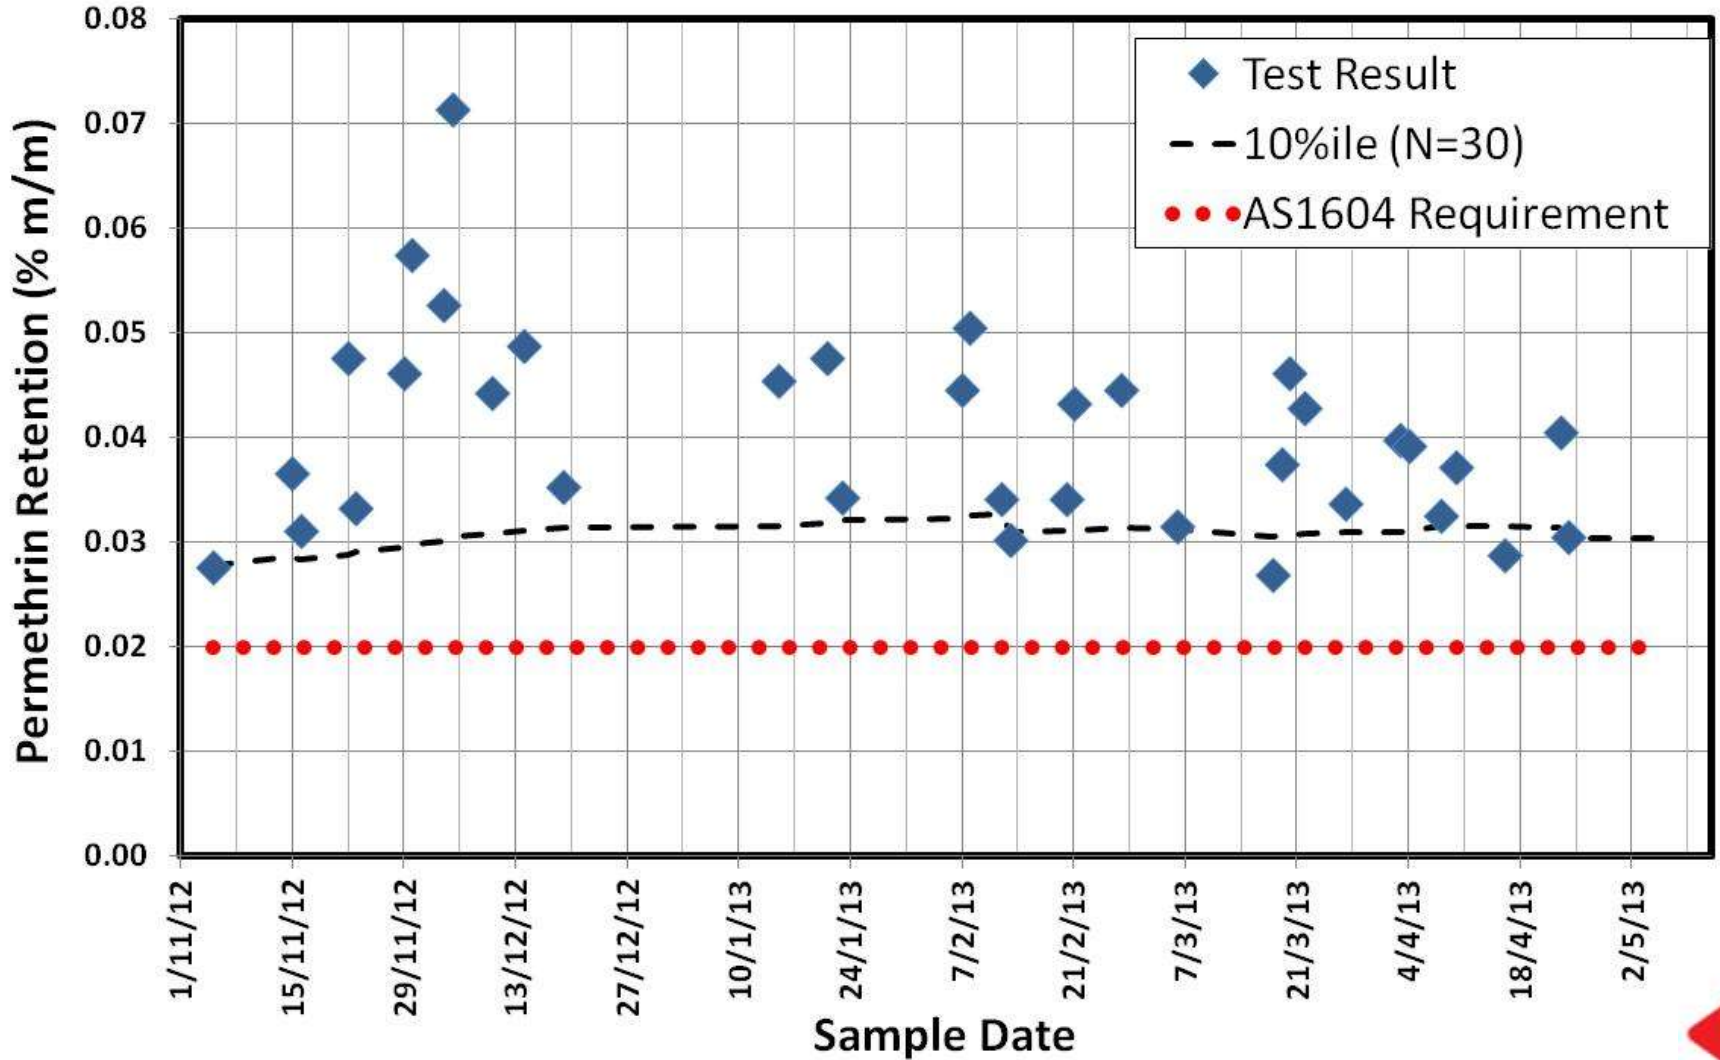
## T2 Red Permethrin Retention 1/11/12 - 6/5/13
