Construction Benefits –Termites

Termites

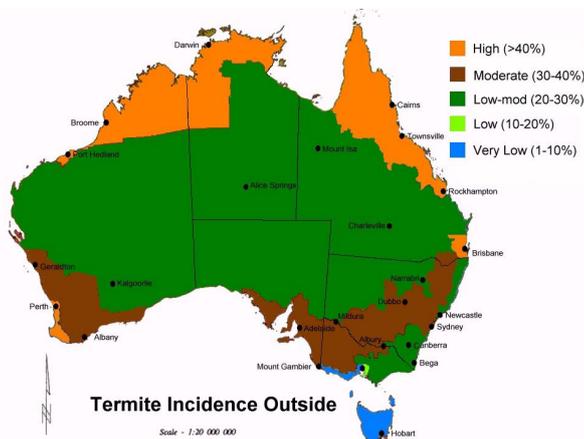
Figure 1 Termite incidence from a survey of households carried out by the CSIRO (Source: (Cookson & Trajstman, 2002)

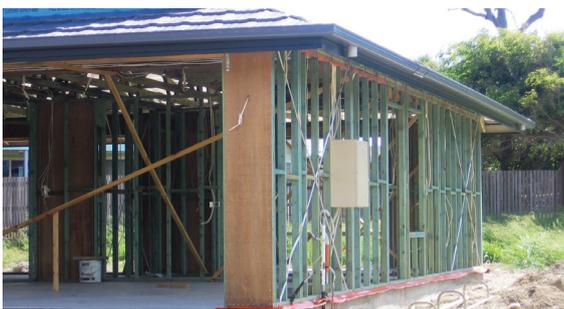
Figure 2 Termite management for this house includes concrete slab physical barrier coupled with chemically impregnated plastic perimeter and penetration barriers and termite treated wall and roof framing.

- Effective physical barriers may include a raised timber floor combined with ant caps (metal barrier); or using a concrete slab combined with a stainless steel mesh or crushed aggregate granite for the ground floor, and then building with timber in the upper floors.
- Termiticides can also be added to the soil to form a chemical barrier that can prevent or deter termites from entering a structure. However, these barriers have a limited life in the soil and will need to be replenished to remain intact – this will be outlined in the instructions on the termiticide label.

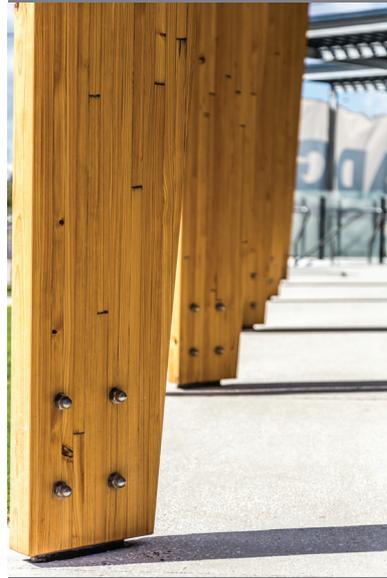
Figure 3. Glue laminated timber columns used in the construction of Stella Maris Church, Maroochydore. Image courtesy of Hyne Timber.

The Stella Maris Church, located in Maroochydore, Queensland, incorporates both a physical and chemical barrier system. The Hyne Timber Glue Laminated Timber columns are treated with a termiticide that repels termites and other wood destroying insects. The treatment is impregnated into the sapwood cells of the timber, creating a protective envelope

that lasts for the design life of the building. The steel base connections add an additional layer of protection forming a physical barrier – preventing subterranean termites from travelling through the centre of the timber unseen.
